CDF Operations Report

JJ Schmidt

28-April-2008

All Experimenters' Meeting

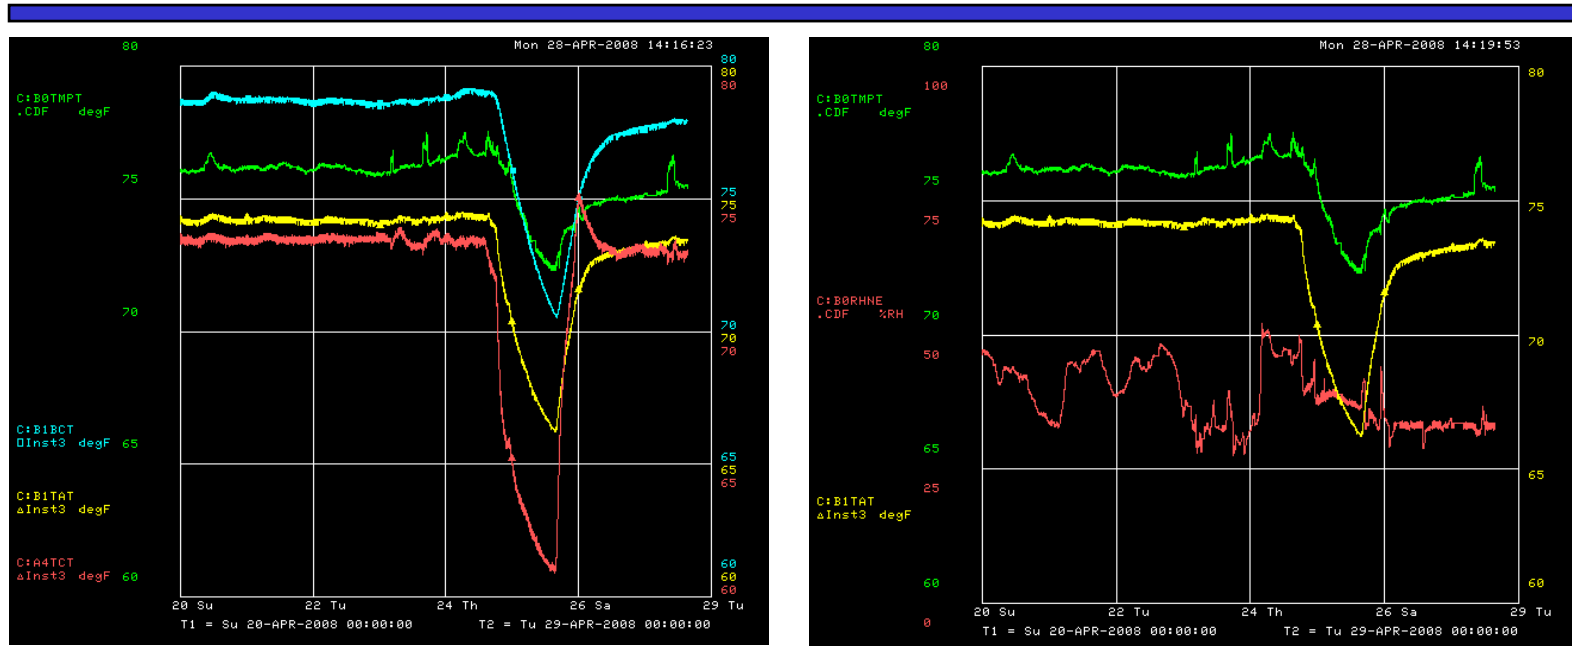
- On Friday morning CDF lowered the humidity target setpoint for HVAC in the hall to a value used last August.
- The HVAC regulates on pressure differential, humidity, and temperature.
- Evidently (for ambient conditions of last week), the "re-warming" heater could not keep up with the chillers removing moisture and hall went into a temperature slide. We did not pick this up.
- Humidity target was reset after Tevatron experts realized what was going on... (you have probably already heard this story earlier in meeting). Quads in B0 were rocking and rolling Sorry.
- We will be more cautious next time and will investigate better algorithm or at least better alarms.

Quad column temps: B1BCT,A4TCT,B1TAT (air)
Collision Hall temp: BOTMPT (top of hall)
Collision Hall relative humidity: BORHNE (northeast corner)
